MERRIMACK RIVER BASIN  
HUDSON, MASSACHUSETTS

MAIN STREET DAM  
MA 00448

PHASE I INSPECTION REPORT  
NATIONAL DAM INSPECTION PROGRAM

MAY 1979

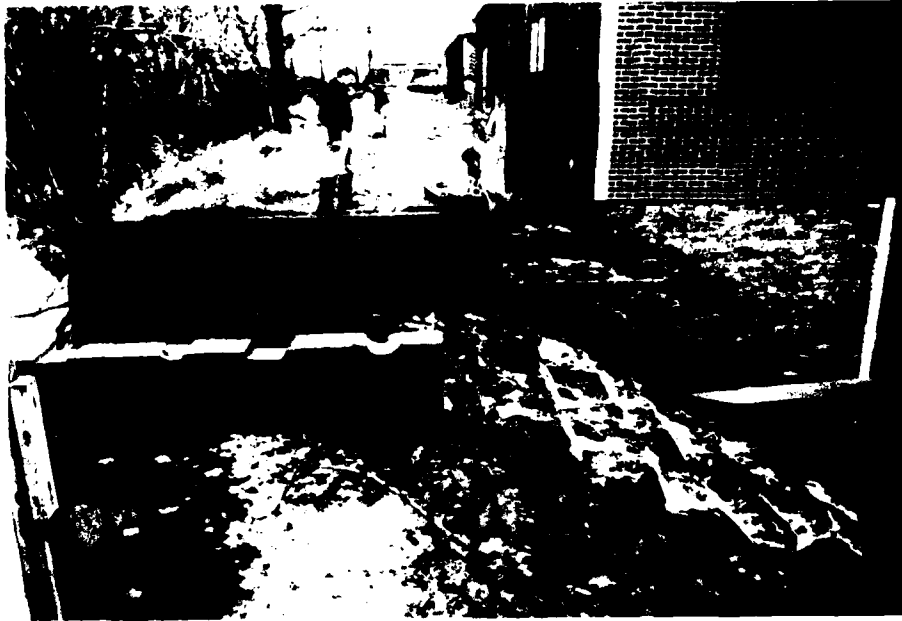
A. Overview of spillway and left embankment from right embankment.

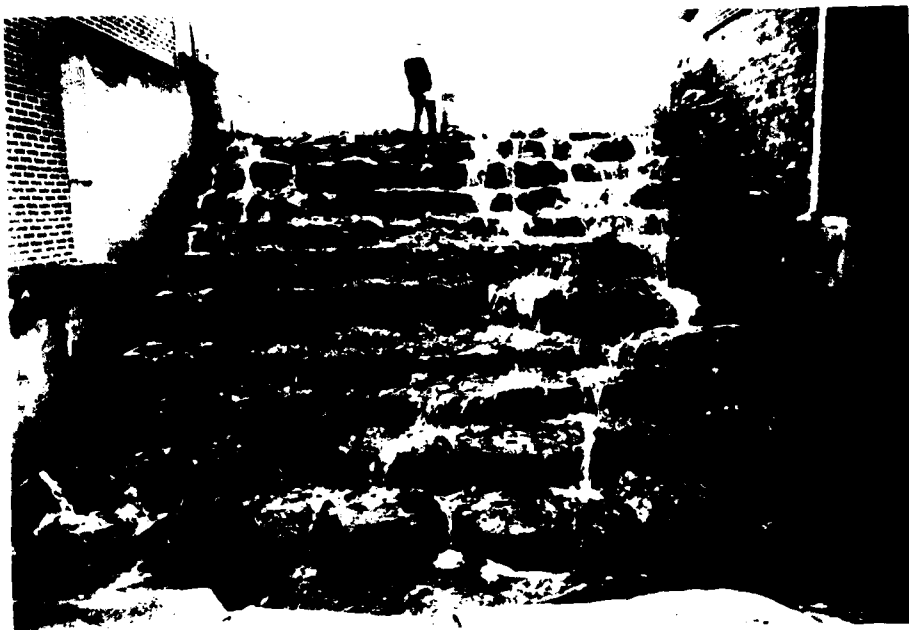
1. Overview of spillway from downstream parking lot.

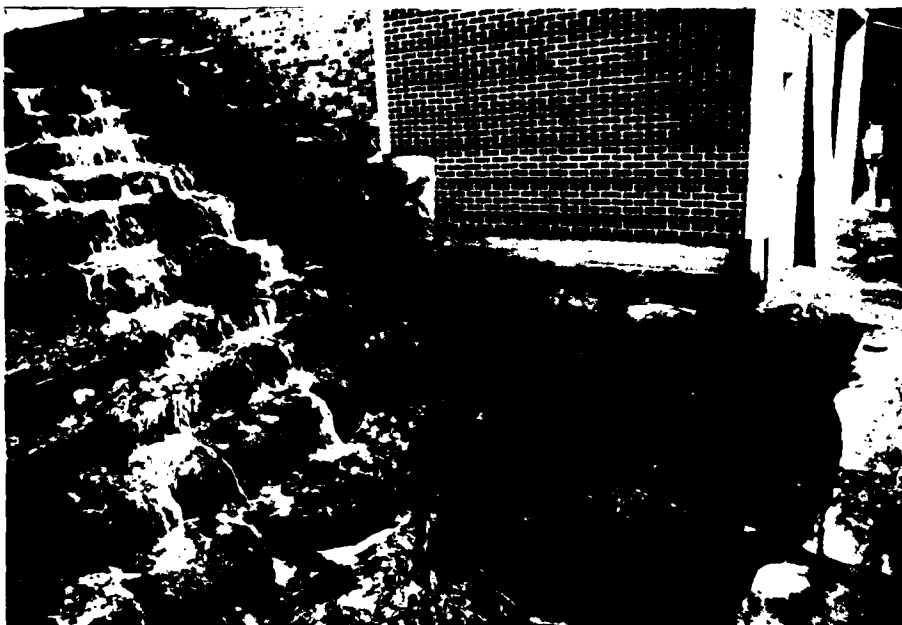
2. View of left side of spillway from parking lot.

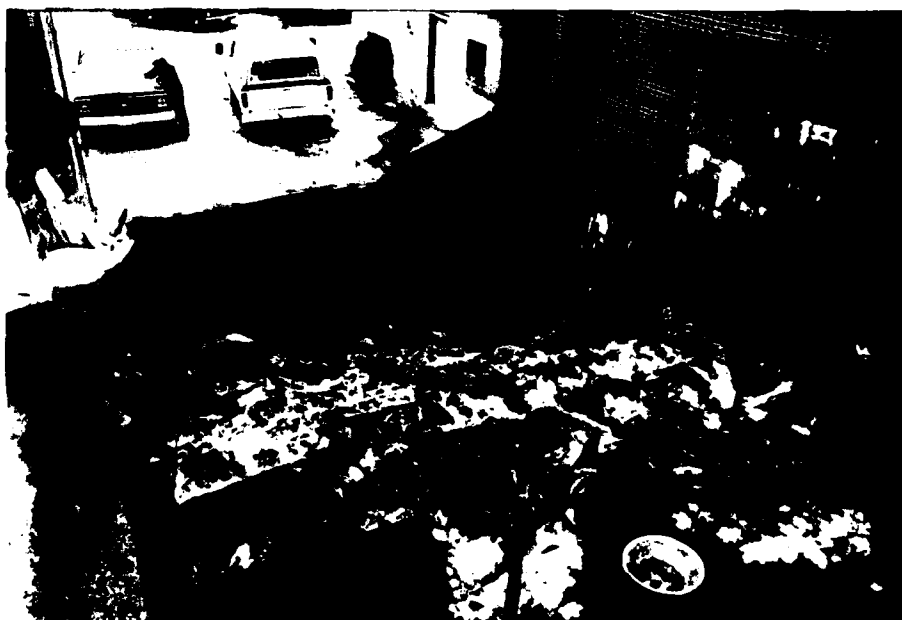
3. View of spillway and parking lot downstream.

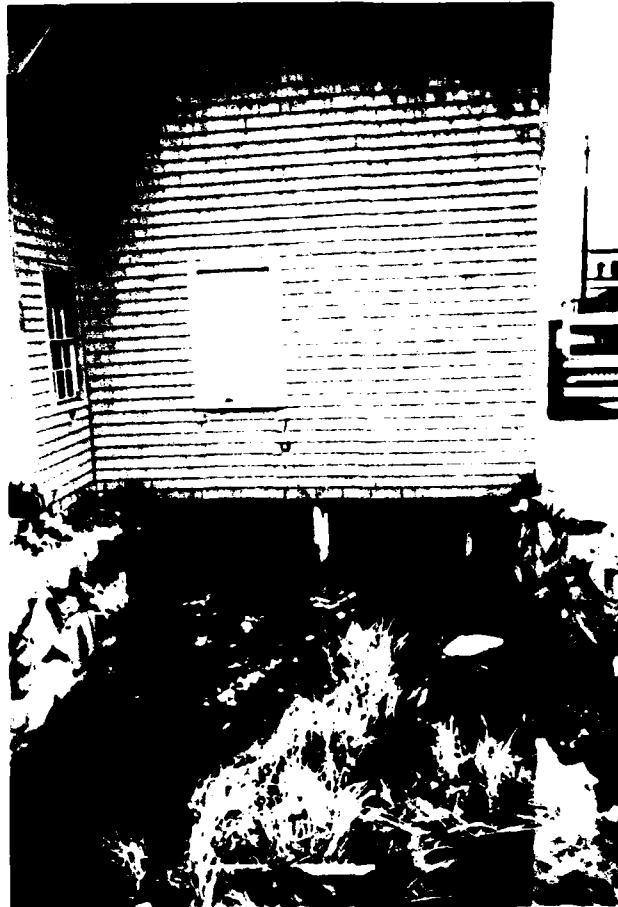
The fieldstone walls of the stilling basin and downstream channel are generally in good condition. Some smaller stones are missing and voids are developing in the joints.

4. View of downstream channel and culvert under building.
